# Manhole Inspection Summary

Manhole # S53W1\_007MH

Insp Date: **6/6/08 11:19 AM**

**Location** Address: **1955 Chesapeake Ave.**

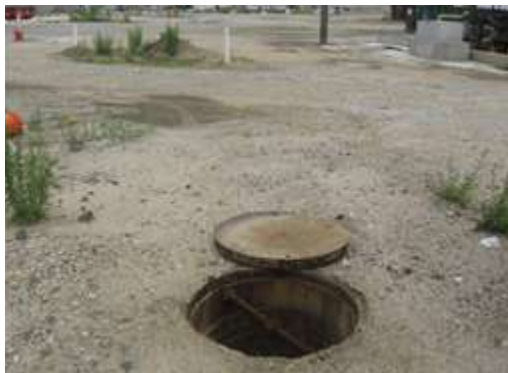
Location View

Comments **On bare ground within private property.**

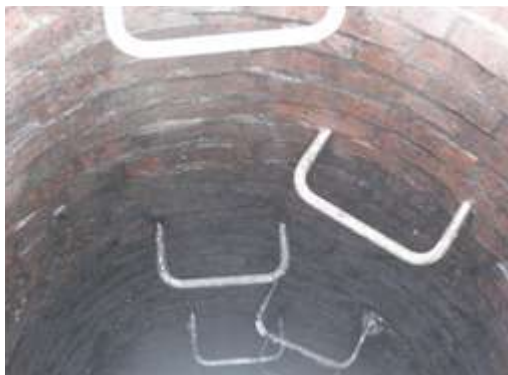
Steps

**Steps** Count: **8** Missing: **0** ☐ Corroded

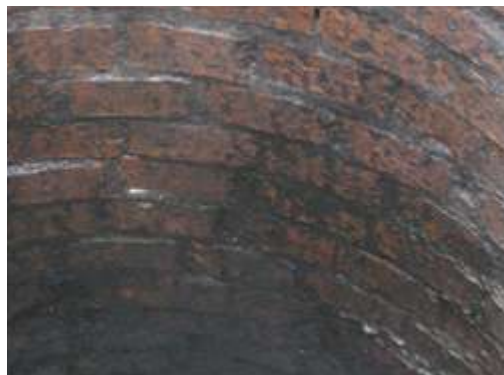
Defect 1

Infiltration: ☐ None ☐ Joint ☐ Cracks ☐ Mortar ☐ Roots ☒ **Wall**

Infiltration

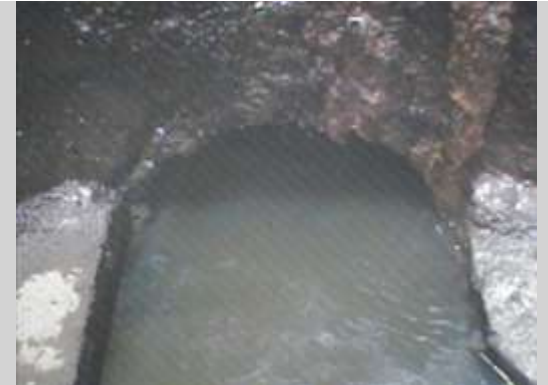
12 O'Clock Outflow

18 in. Circular Gravity Sewer  
Pipe Out @ 12 O'Clock

Pipe Height: **16.8** (in.) Rod and Bar (Angled)  
Pipe Material: **Clay** ☐ Pipe Lined  
Invert Depth: **15.20** (ft.) Flow Characteristics: **Slow**  
Deposits: ☒ None ☐ Mud ☐ Sludge ☐ Debris ☐ Grease  
Silt Depth: (in.) Deposits Extent:  
Infiltration: **None** Pipe Seal Cond: **Sound**

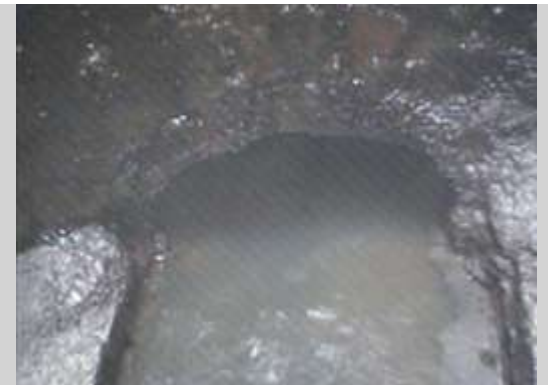
3 O'Clock Inflow

18 in. Circular Gravity Sewer  
Pipe In @ 3 O'Clock

Pipe Height: **16.8** (in.) Rod and Bar (Angled)  
Pipe Material: **Clay** ☐ Pipe Lined  
Invert Depth: **15.10** (ft.) Flow Characteristics: **Slow**  
Deposits: ☒ None ☐ Mud ☐ Sludge ☐ Debris ☐ Grease  
Silt Depth: (in.) Deposits Extent:  
Infiltration: **None** Pipe Seal Cond: **Sound**
